September 1984
Final Report

DOT HS 806 666

AIRBAG DEMONSTRATION PROGRAM
PHASE III

13. Type of Report and Period Covered Final April - August, 1984	
		14. Sponsoring Agency Code	
		15. Supplementary Notes	
16. Abstract <u>Abstract</u> Driving and Barrier Tests were performed to determine acceleration levels required to cause an accidental deployment of a Romeo-Kojyo airbag system and a Breed Corporation Mechanical Airbag System sensor.

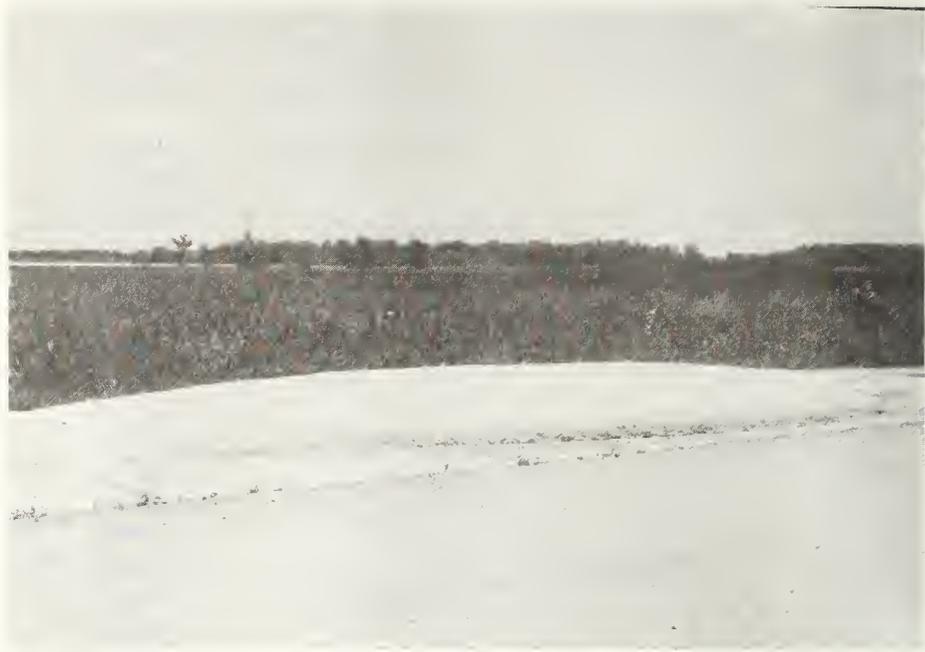
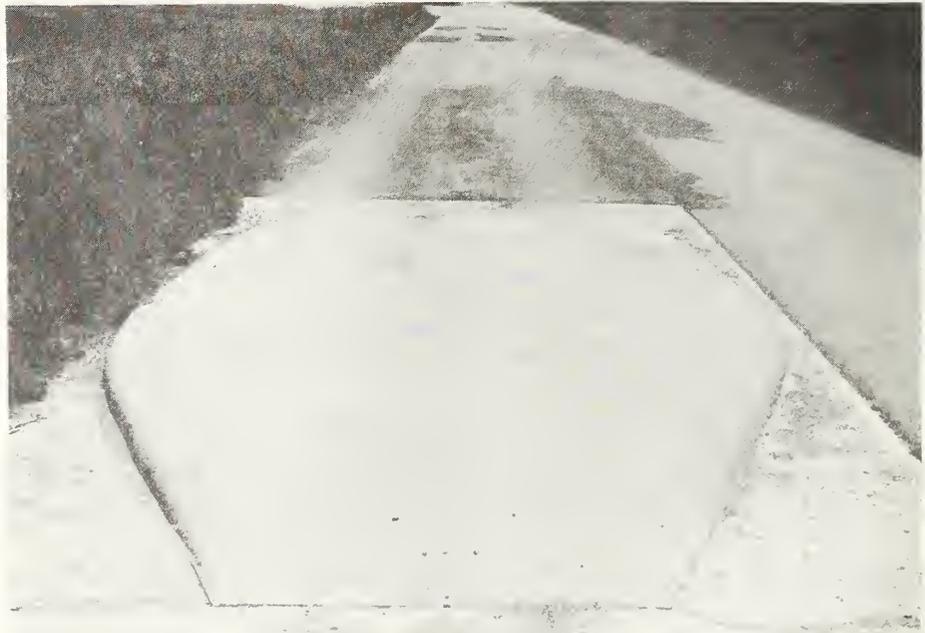
Single Bump (Figs. 1 & 2) An oblong shaped concrete block, six inches tall with a ramp at both ends. The entrance ramp starts at ground level and is 48 inches wide. It rises to six inches over a distance of seven feet and widens out to 120 inches at the same point. The exit ramp tapers from 120 inches to 102 inches in width and comes back to ground level over a distance of 66 inches. The bump is flat on top over a length and width of ten feet.

Single Bump, side view

Single Bump,
Entering View

Both vehicles were driven over the single bump at speeds building from 25 MPH to 50 MPH. Each was driven over the stagger bumps at speeds building from 25 MPH to 45 MPH. The LTD was driven through the ditch at 20 MPH and the Dodge at 10, 20, and 25 MPH in the less severe direction and 10 and 15 MPH in the more severe direction. The LTD was driven over the potholed road at speeds up to 40 MPH and the single pothole at speeds up to 30 MPH. None of these tests caused the Romeo-Kojyo airbag system to fire on either vehicle. The Breed Corporation sensor tripped on several occasions as documented in Appendices I & II. Each vehicle sustained damage to the front suspension and frame. In addition, the LTD showed visible damage to the bodywork upon completion of the driving tests. (Figs. 10, 11, & 12)

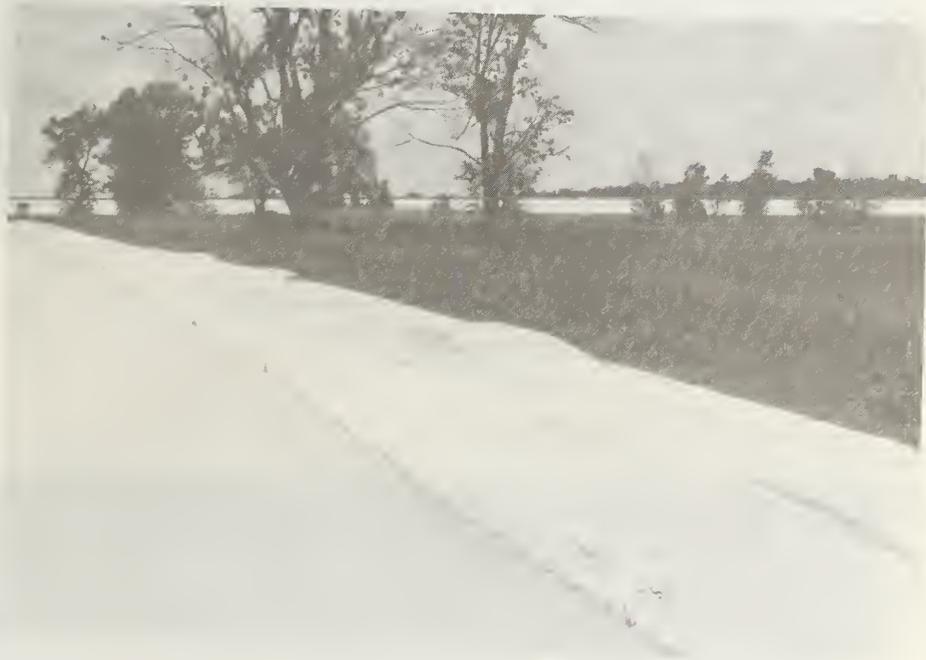
Stagger Bumps (Fig. 3) A series of smaller ramped bumps, each being sixteen feet long start to finish, rising to a height of six inches in the center and having a driving surface 36 inches wide. They are located so that the first, third, and fifth bumps are encountered by the left tires of a vehicle and the second, fourth, and sixth are encountered by the right tires. The track center between left and right side bumps is six feet. The spacing from center to center of the bumps is as follows:

1 - 2 = 18 feet	2 - 3 = 17 feet	3 - 4 = 15 feet
4 - 5 = 30 feet	5 - 6 = 25 feet

Stagger Bumps

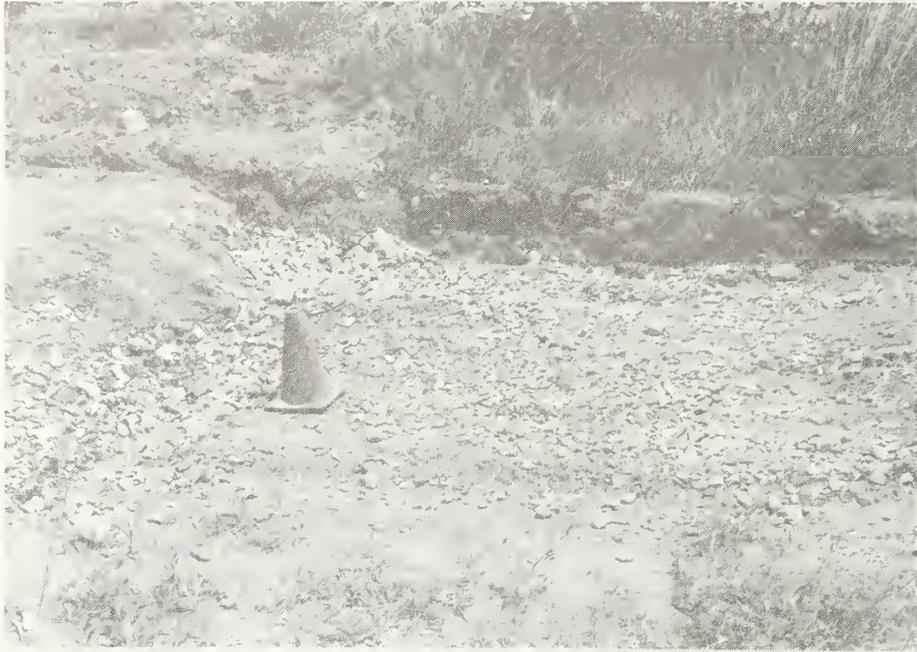
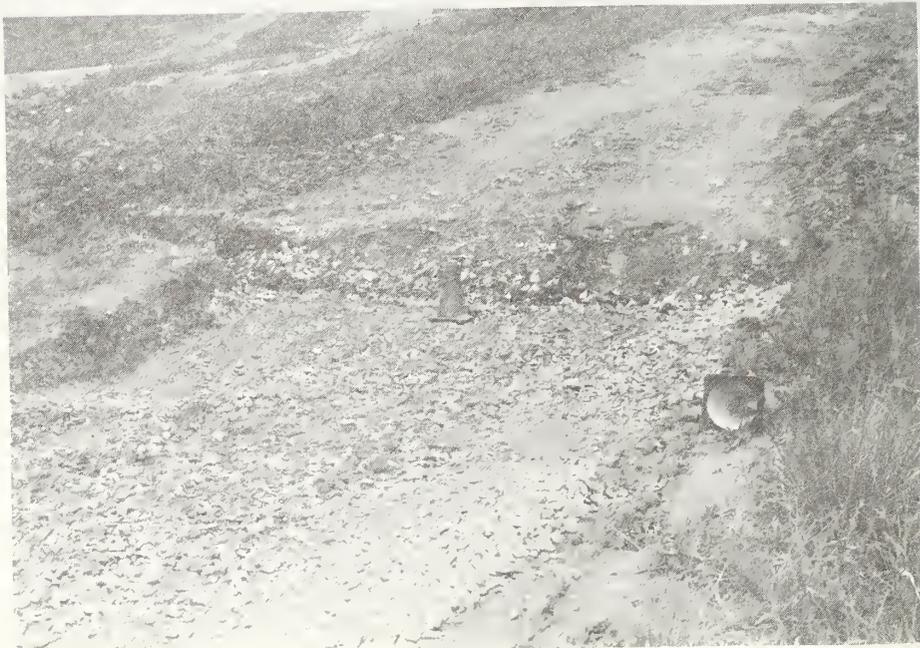
Ditch (Figs. 4 & 5) A man-made pit ten feet wide, twelve feet long, and twelve inches deep. The entrance wall is very nearly vertical having a slightly rounded top edge. The exit side is tapered to create a ramp six feet long. The flat distance along the bottom of the pit from the entrance wall to the start of the exit ramp is four feet.

Ditch, Side View

Ditch, End View

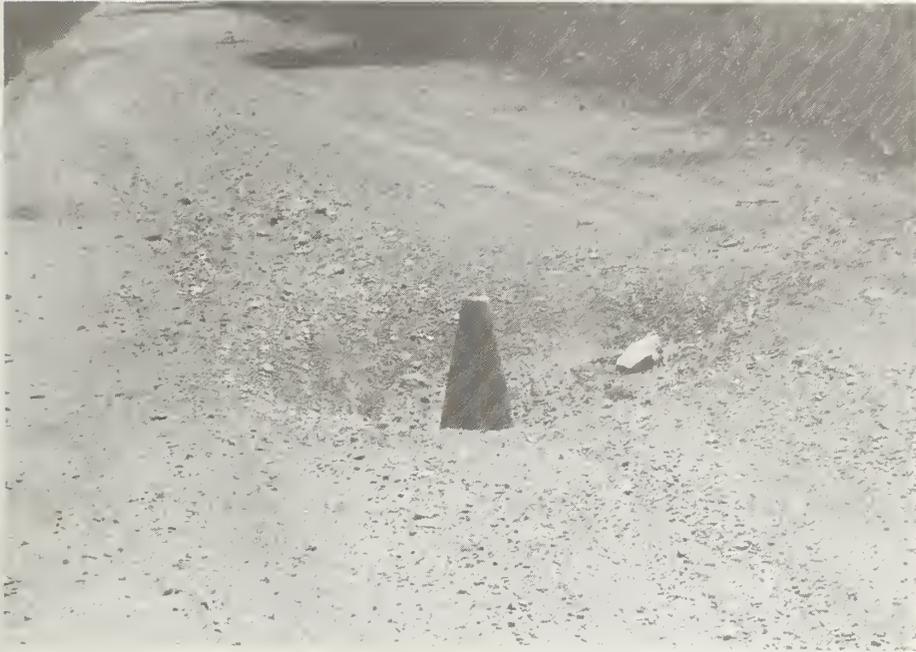
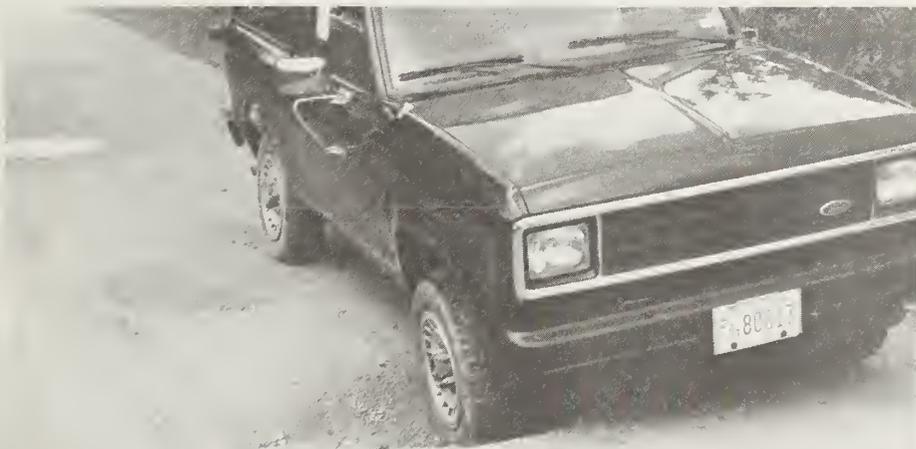
Large Pothole (Figs. 6 & 7) A pothole measuring 30 in. by 30 in. by 10 inches deep.

Large Pothole
With 12" Cone

Large Pothole
With Vehicle

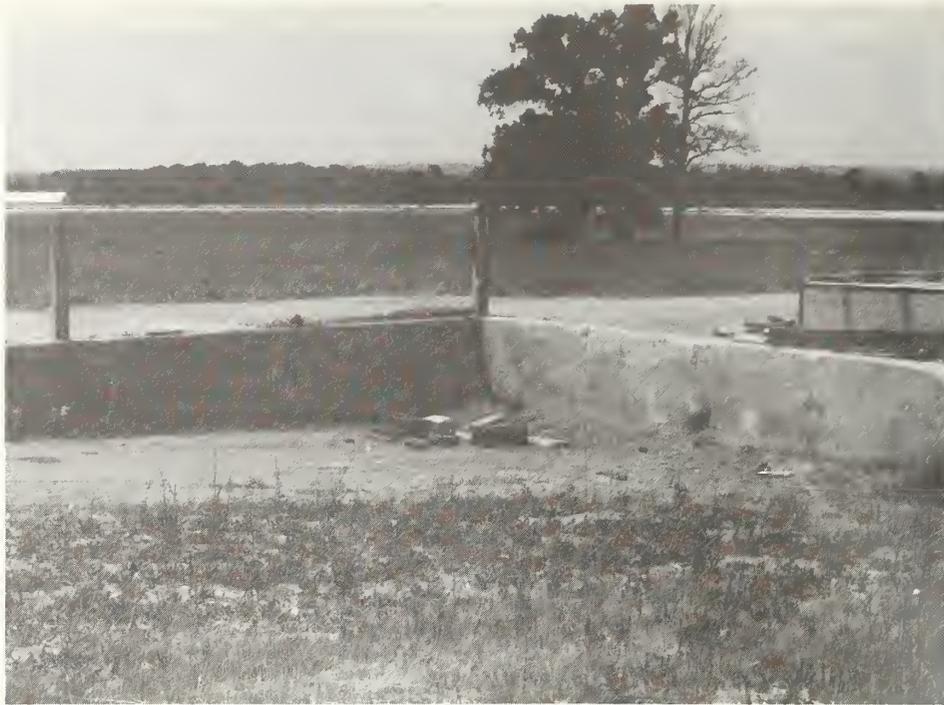
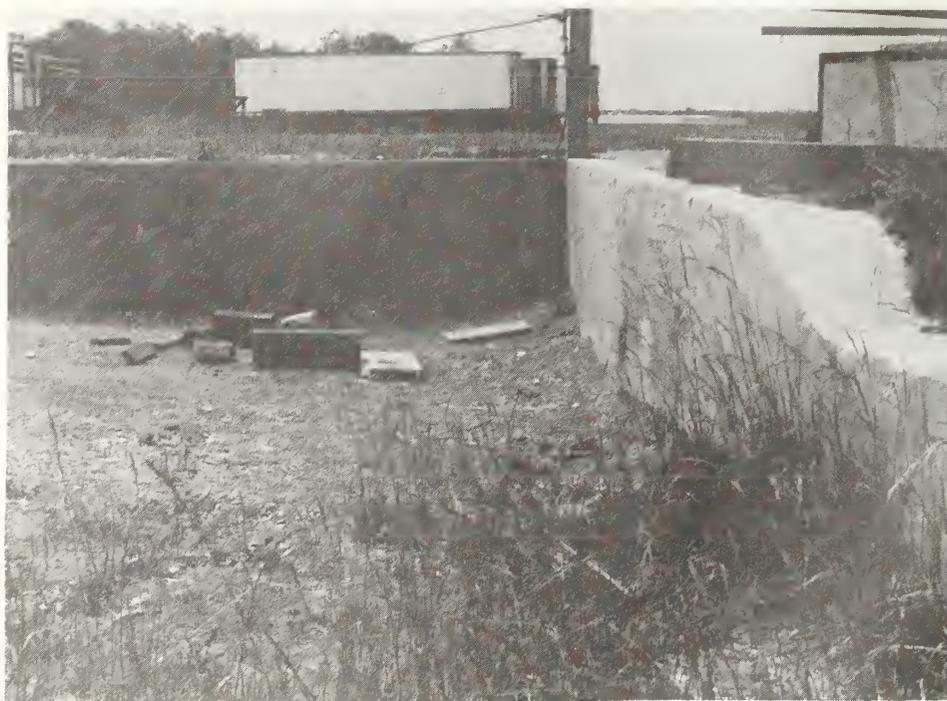
Dock (Figs. 8 & 9) Used as a fixed rigid barrier, this was actually a loading dock which is built such that its upper surface is at ground level thereby creating a ramp to the lower level down which the vehicle could roll without a driver. The striking surface is concrete backed by earth.

Loading Dock
Overall View

Loading Dock
Impact Surface

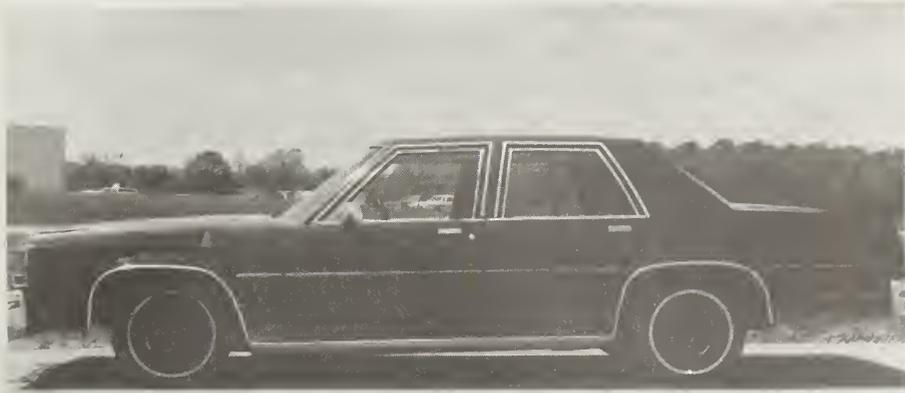
Ford LTD
Post Driving Tests

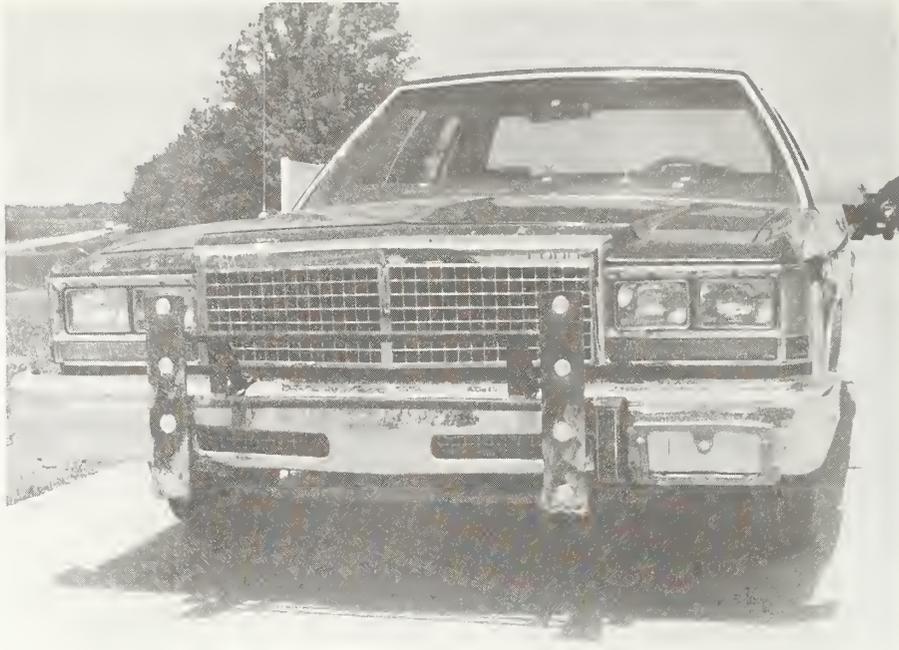
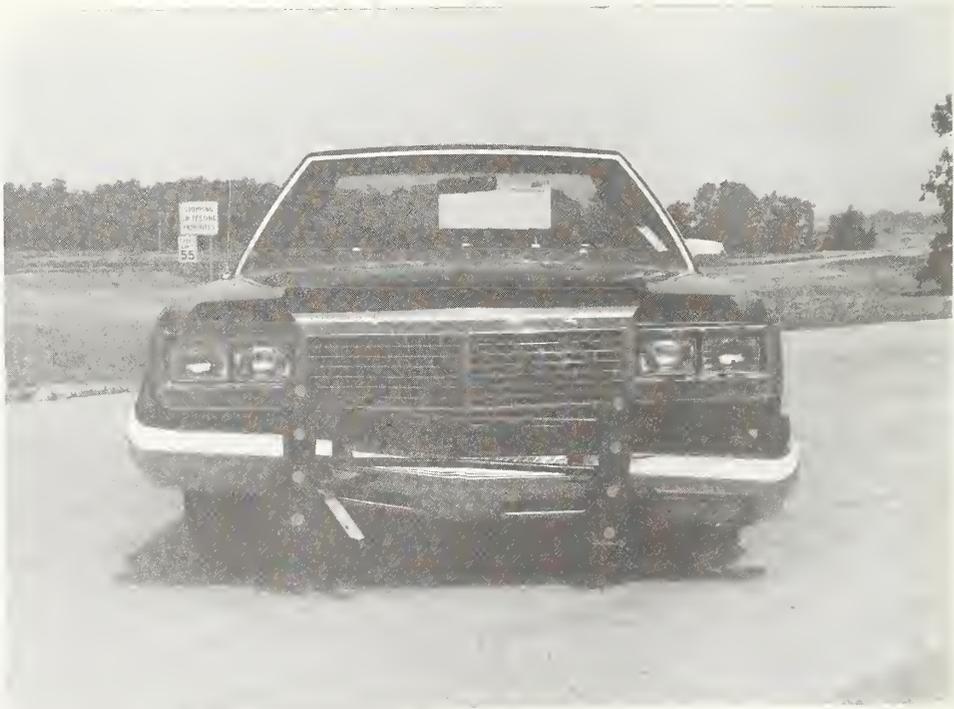
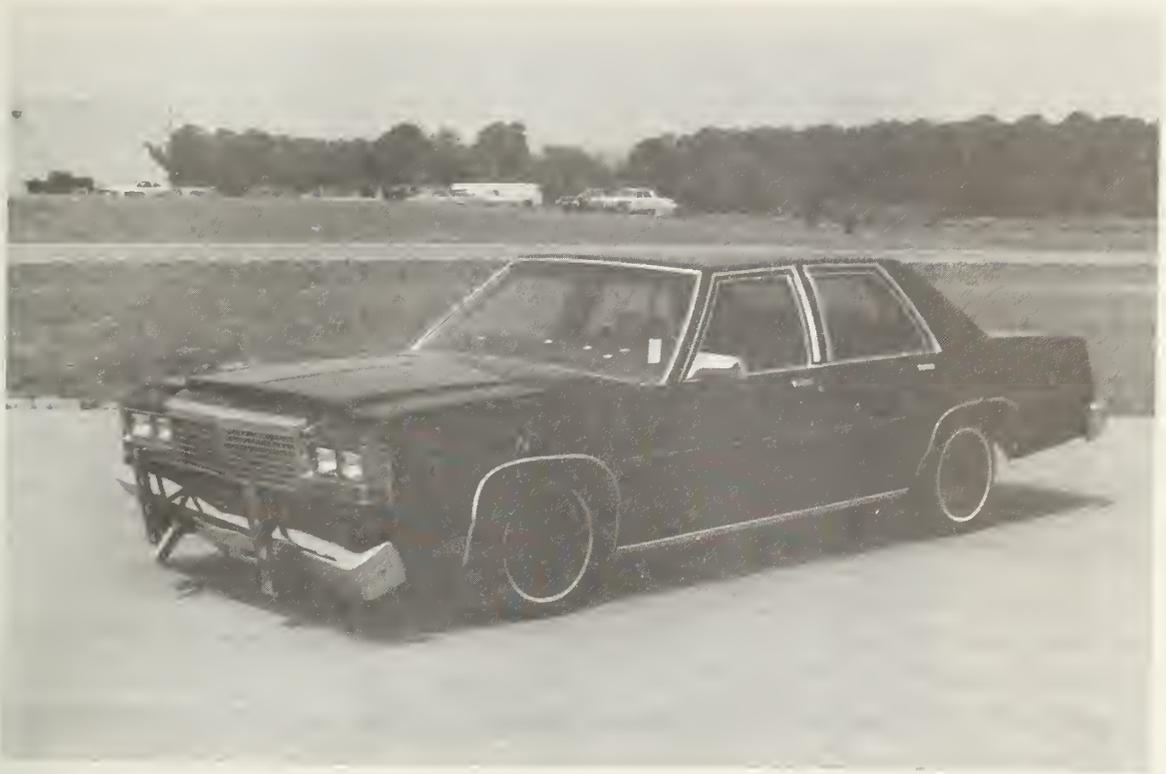
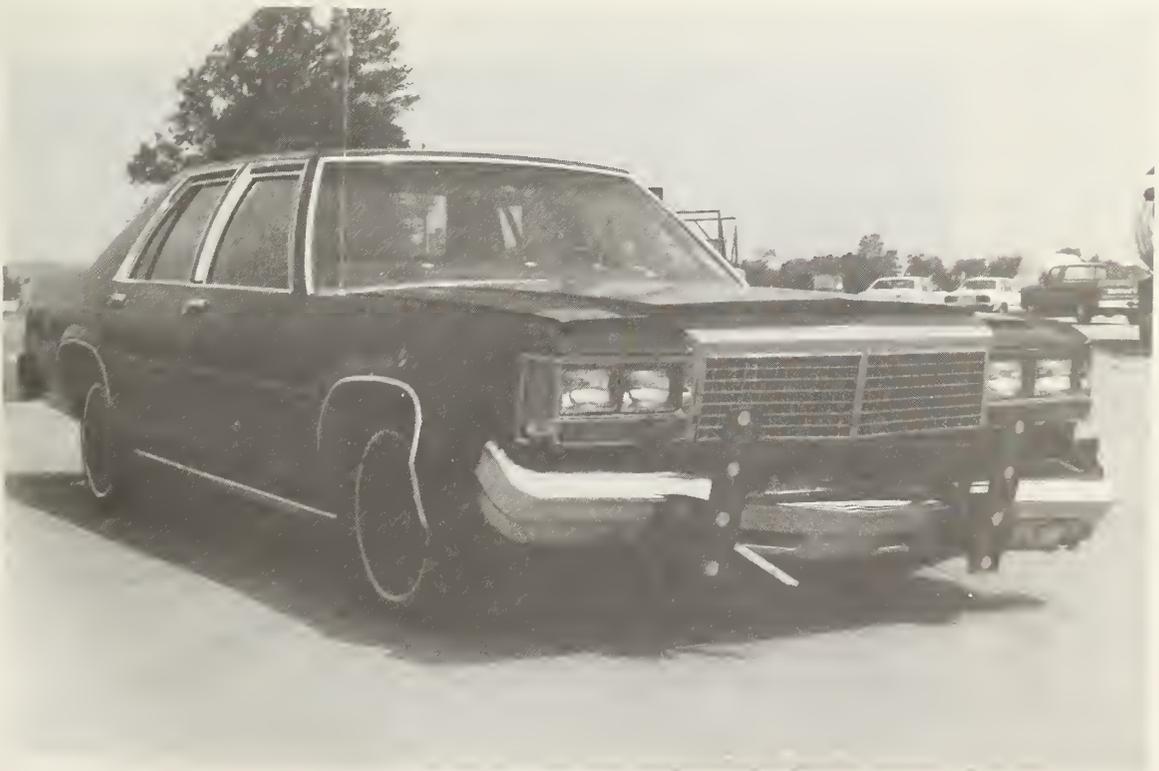
During the course of the loading dock testing, the front end of both vehicles became progressively more damaged. Both vehicles' front bumpers were hanging down at angles approaching 45 degrees before testing was halted. For this reason, results from the loading dock tests should be used only as indicators of trends and not valid data. (Figs. 13 thru 18)

Ford LTD
Pre Loading Dock Testing

Ford LTD
Post Loading Dock Testing

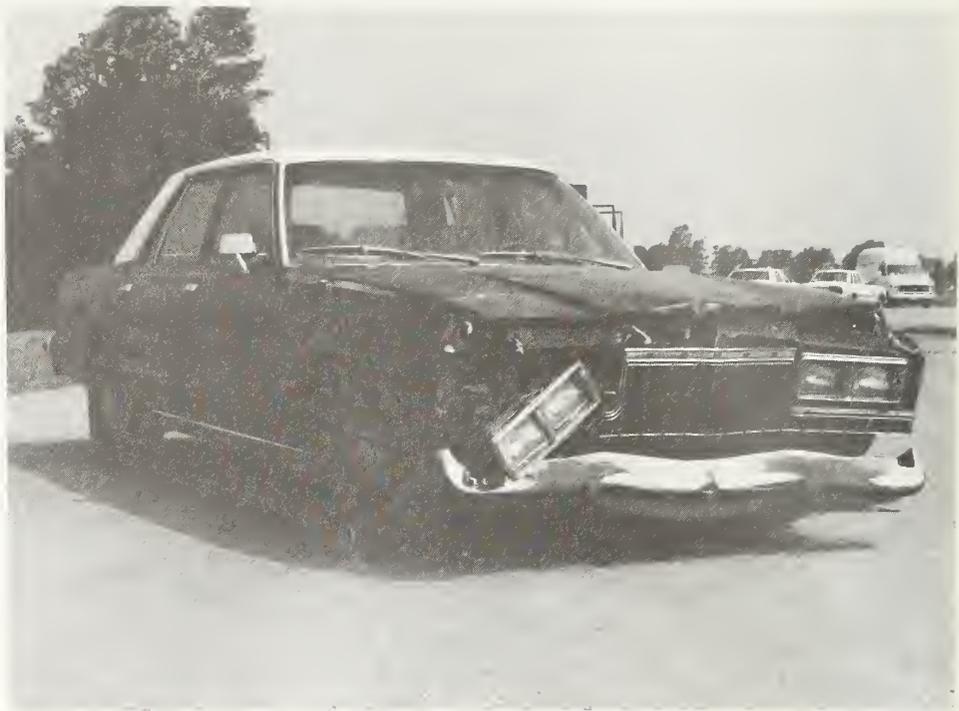
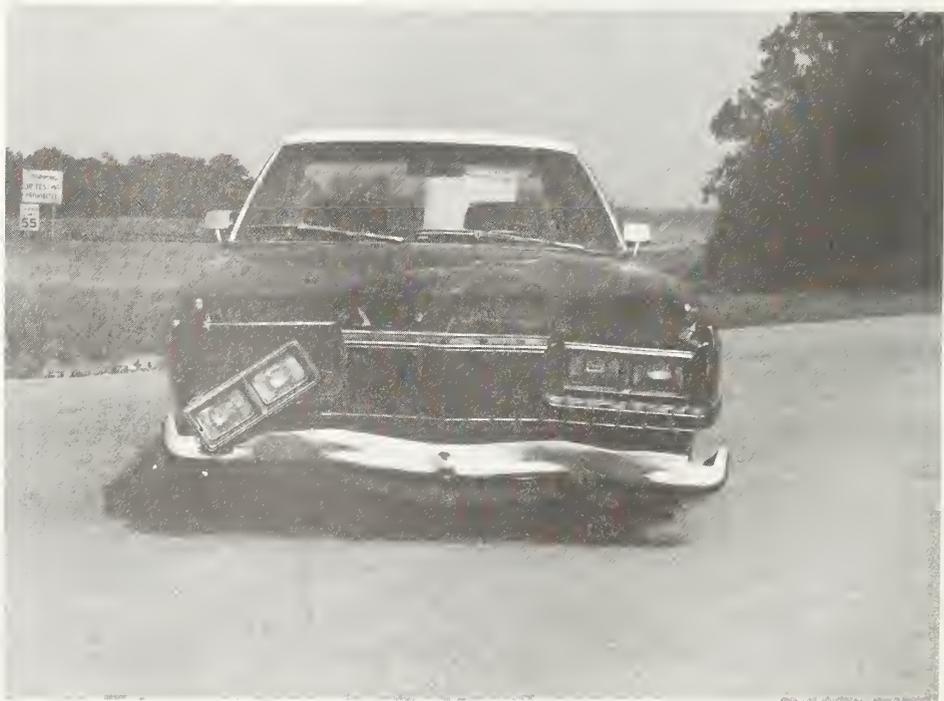
Dodge Diplomat
Post Loading Dock Testing

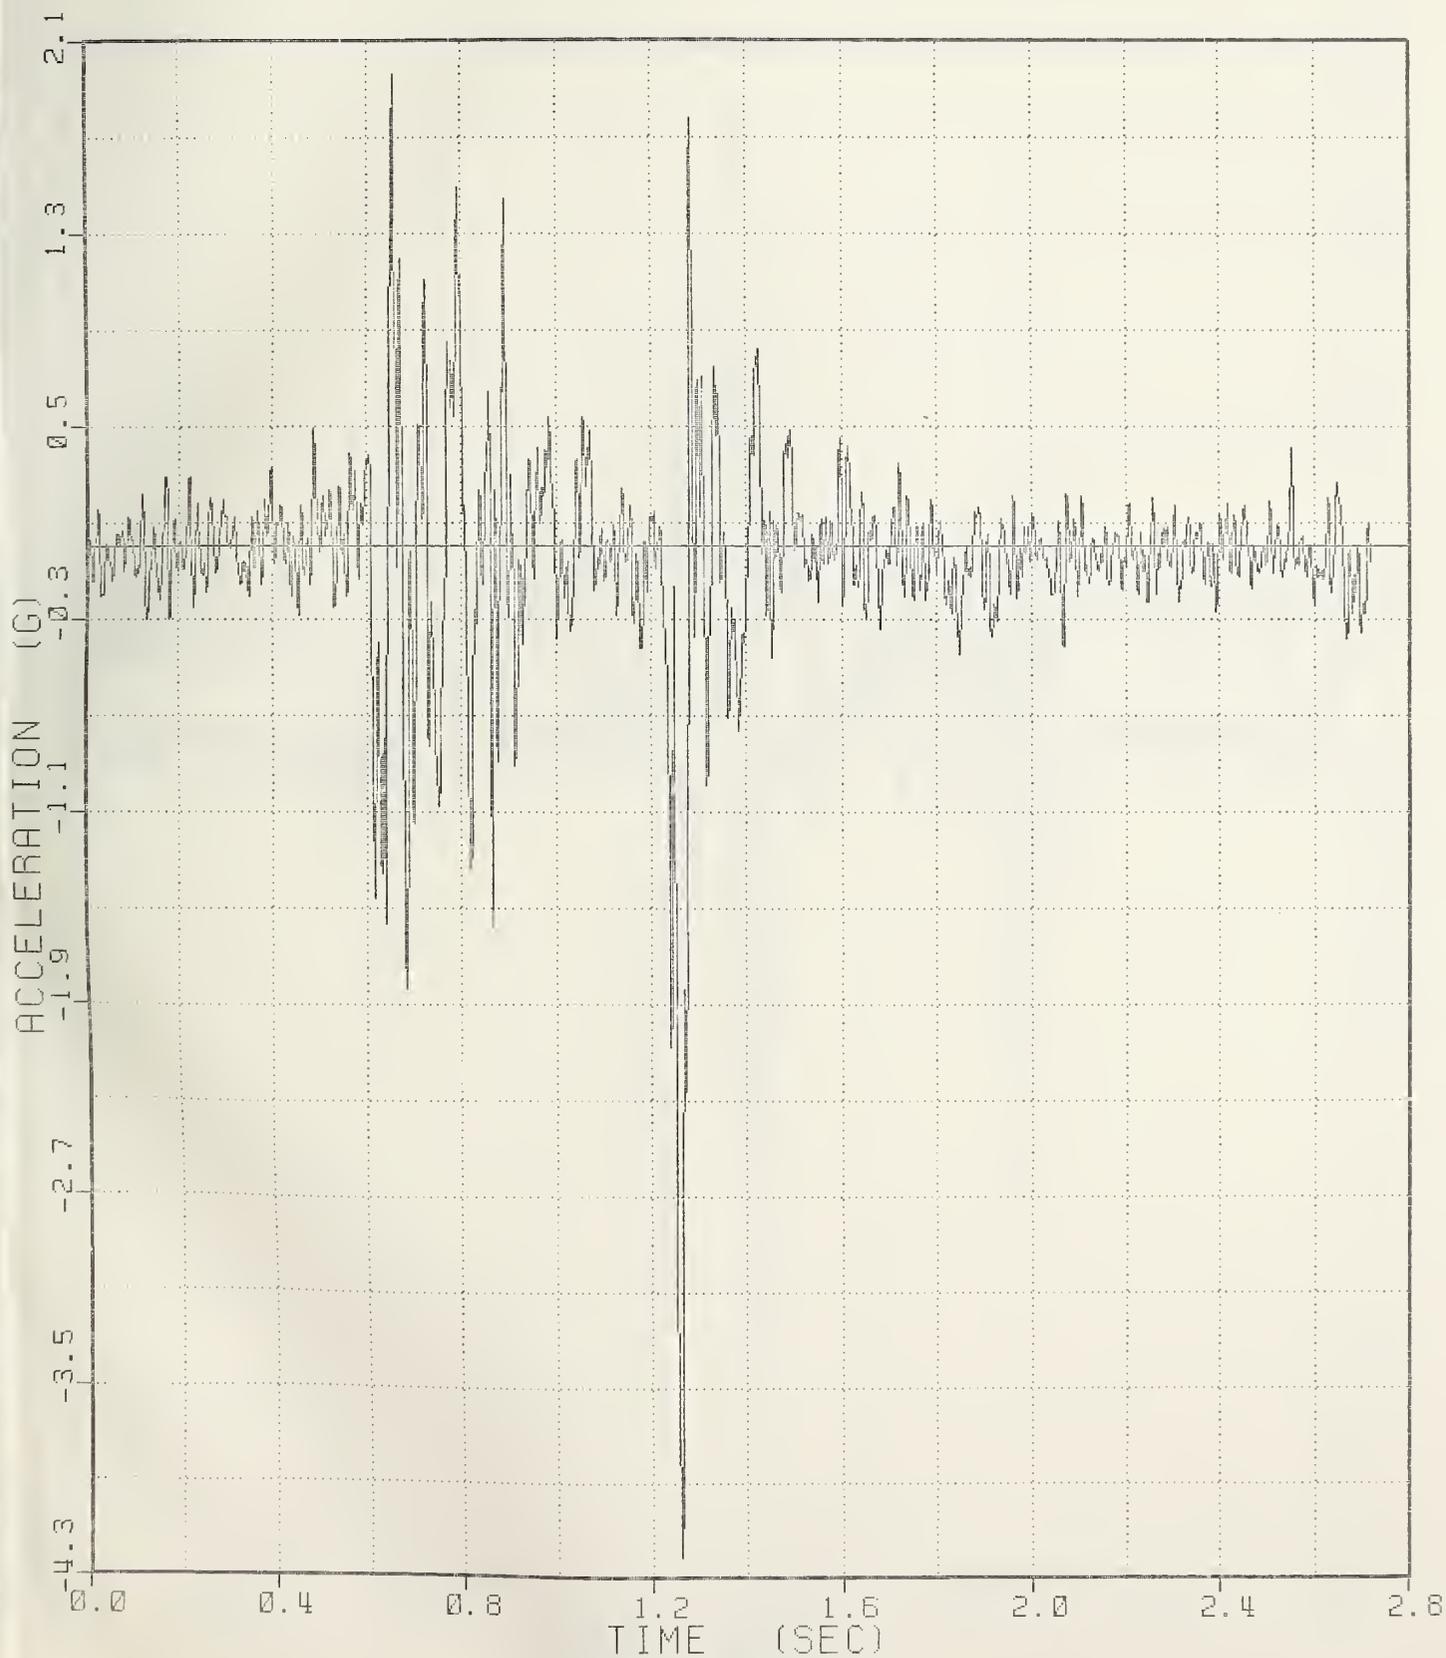
FFCXGR - Acceleration in G's in the X axis at the front frame member on the right side. This is the location of the Right Front Romeo-Kojyo firing sensor.

030ZF RD503-2 TST030 84171083915 28-AUG-84 16:06:36
FFCXGR FILTER = BLPP 100/ 316/ -40 0.0 MPH
MIN, MAX VALUES = -4.21443 0 1.2608 1.96063 0 0.6544

Strip chart data is presented in appendix 3 for the most severe traverse of each driving surface for each car. Note that the most severe traverse is not always the fastest.

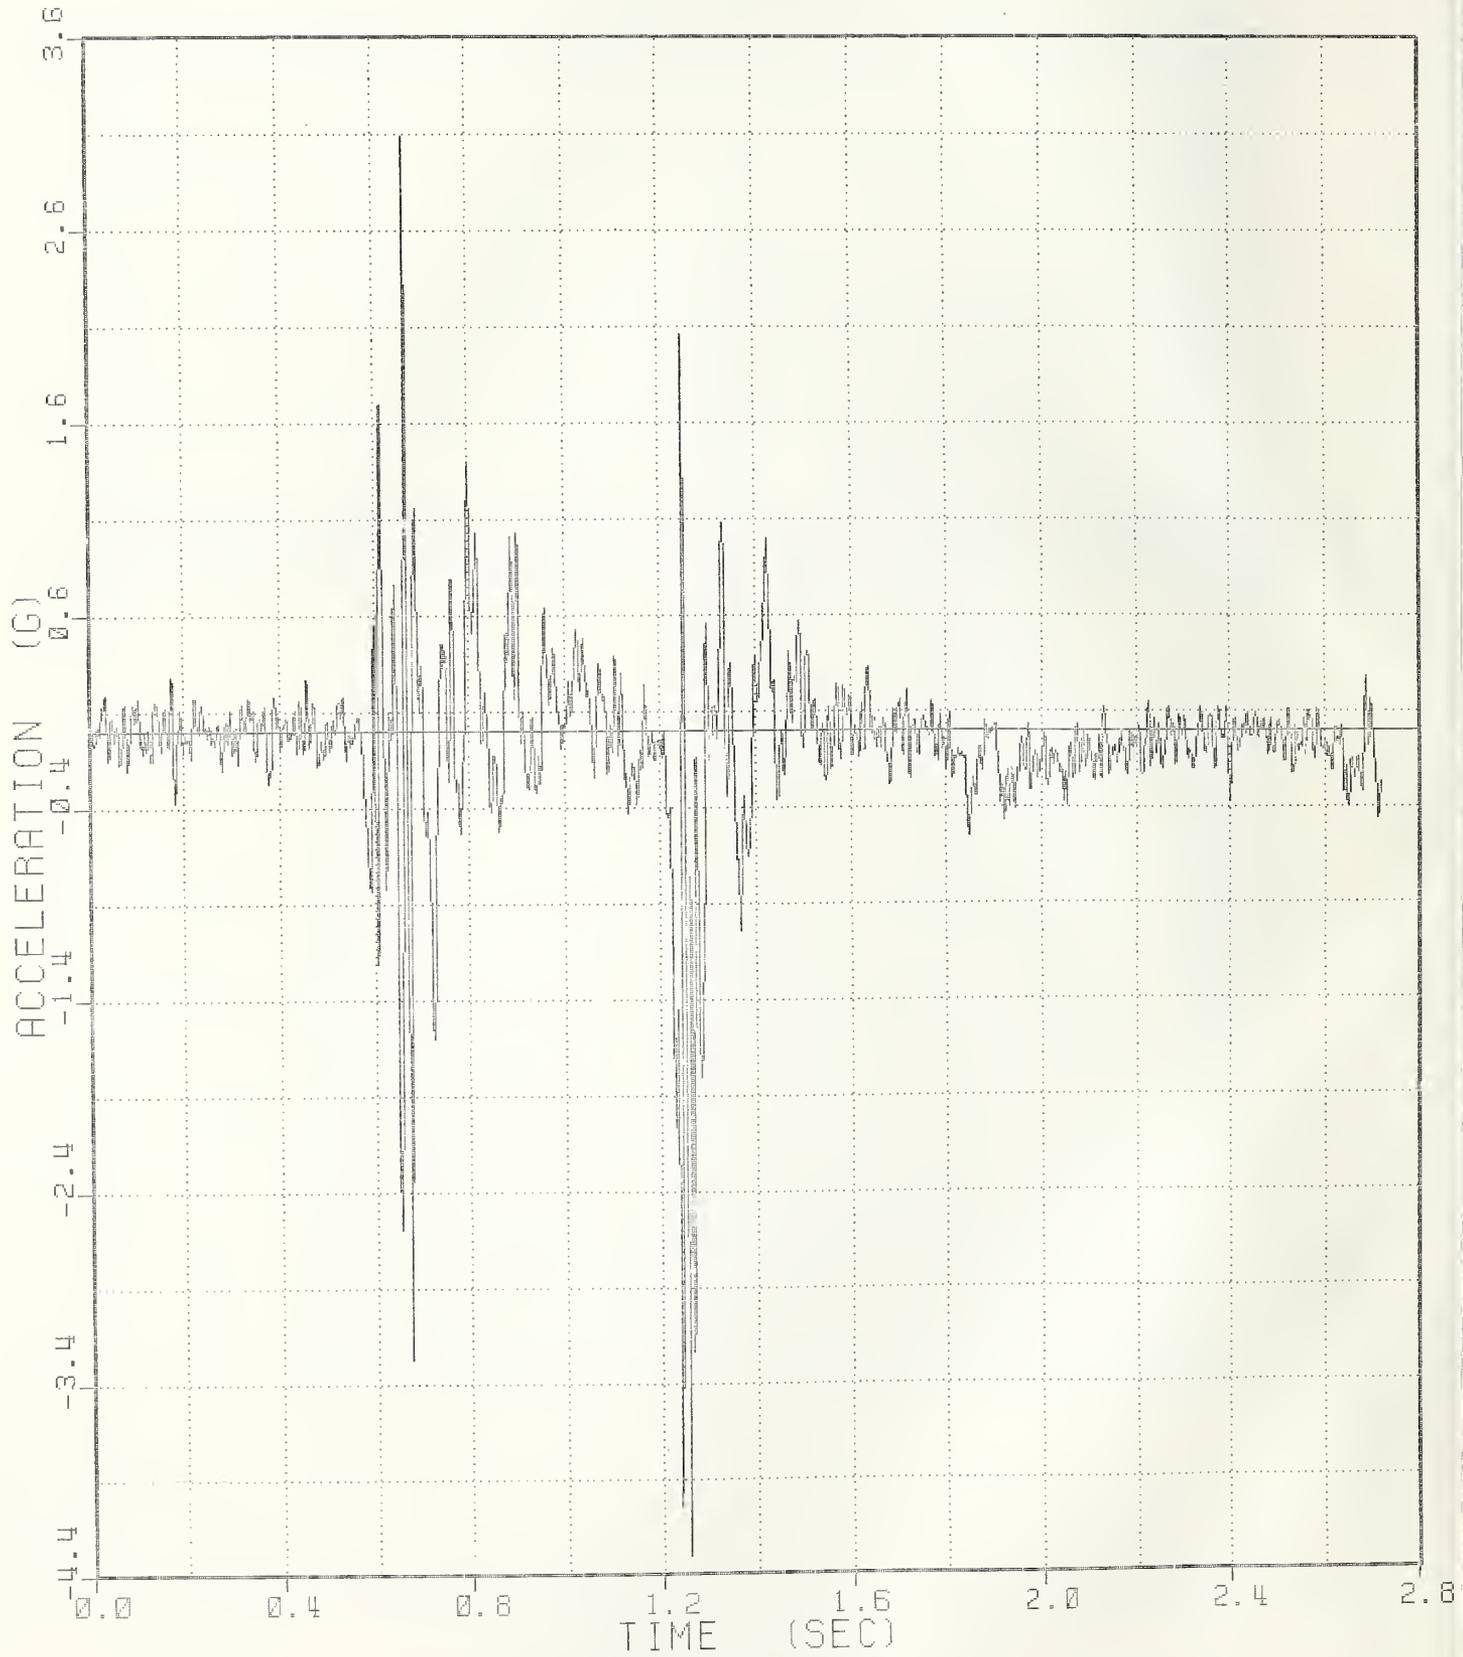
030 FFCXGL

FFCXGL - Same as above except on the left side.

030ZF RD583-2 TST030 84171083915 28-AUG-84 16:06:36
FFCXGL FILTER = BLPP 100/ 316/ -40 0.0 MPH
MIN, MAX VALUES = -4.30218 0 1.2560 3.08939 0 0.6656

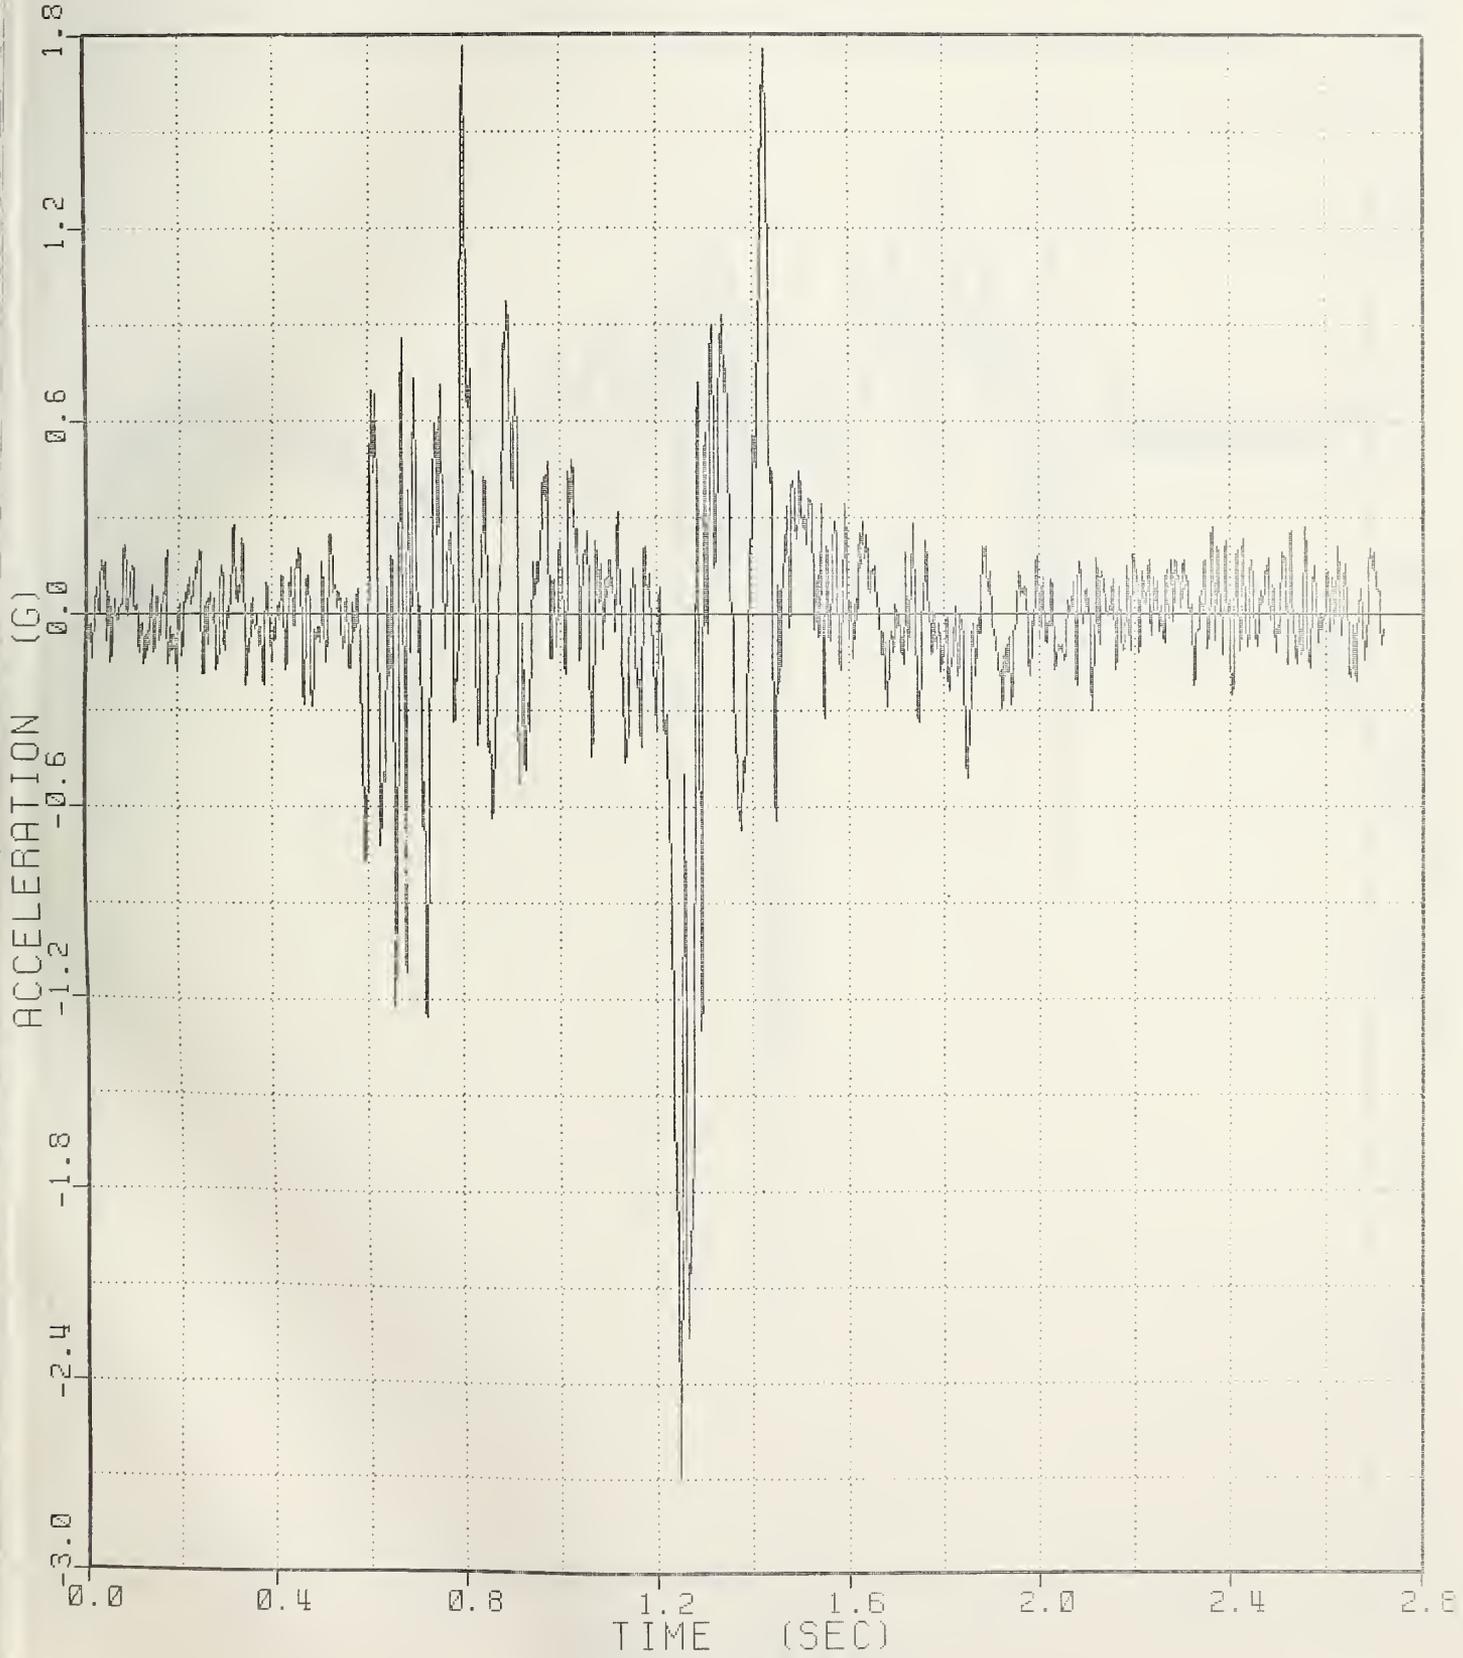
030 SCAPG1

SCAPG1 - Acceleration in G's in the axis of the steering column at the lower end of the steering column.

030ZF RD583-2 TST030 84171083915 28-AUG-84 16:06:36
SCAPG1 FILTER = BLPP 100/ 316/ -40 0.0 MPH
MIN, MAX VALUES = -2.69779 0 1.2480 1.77098 0 0.8000

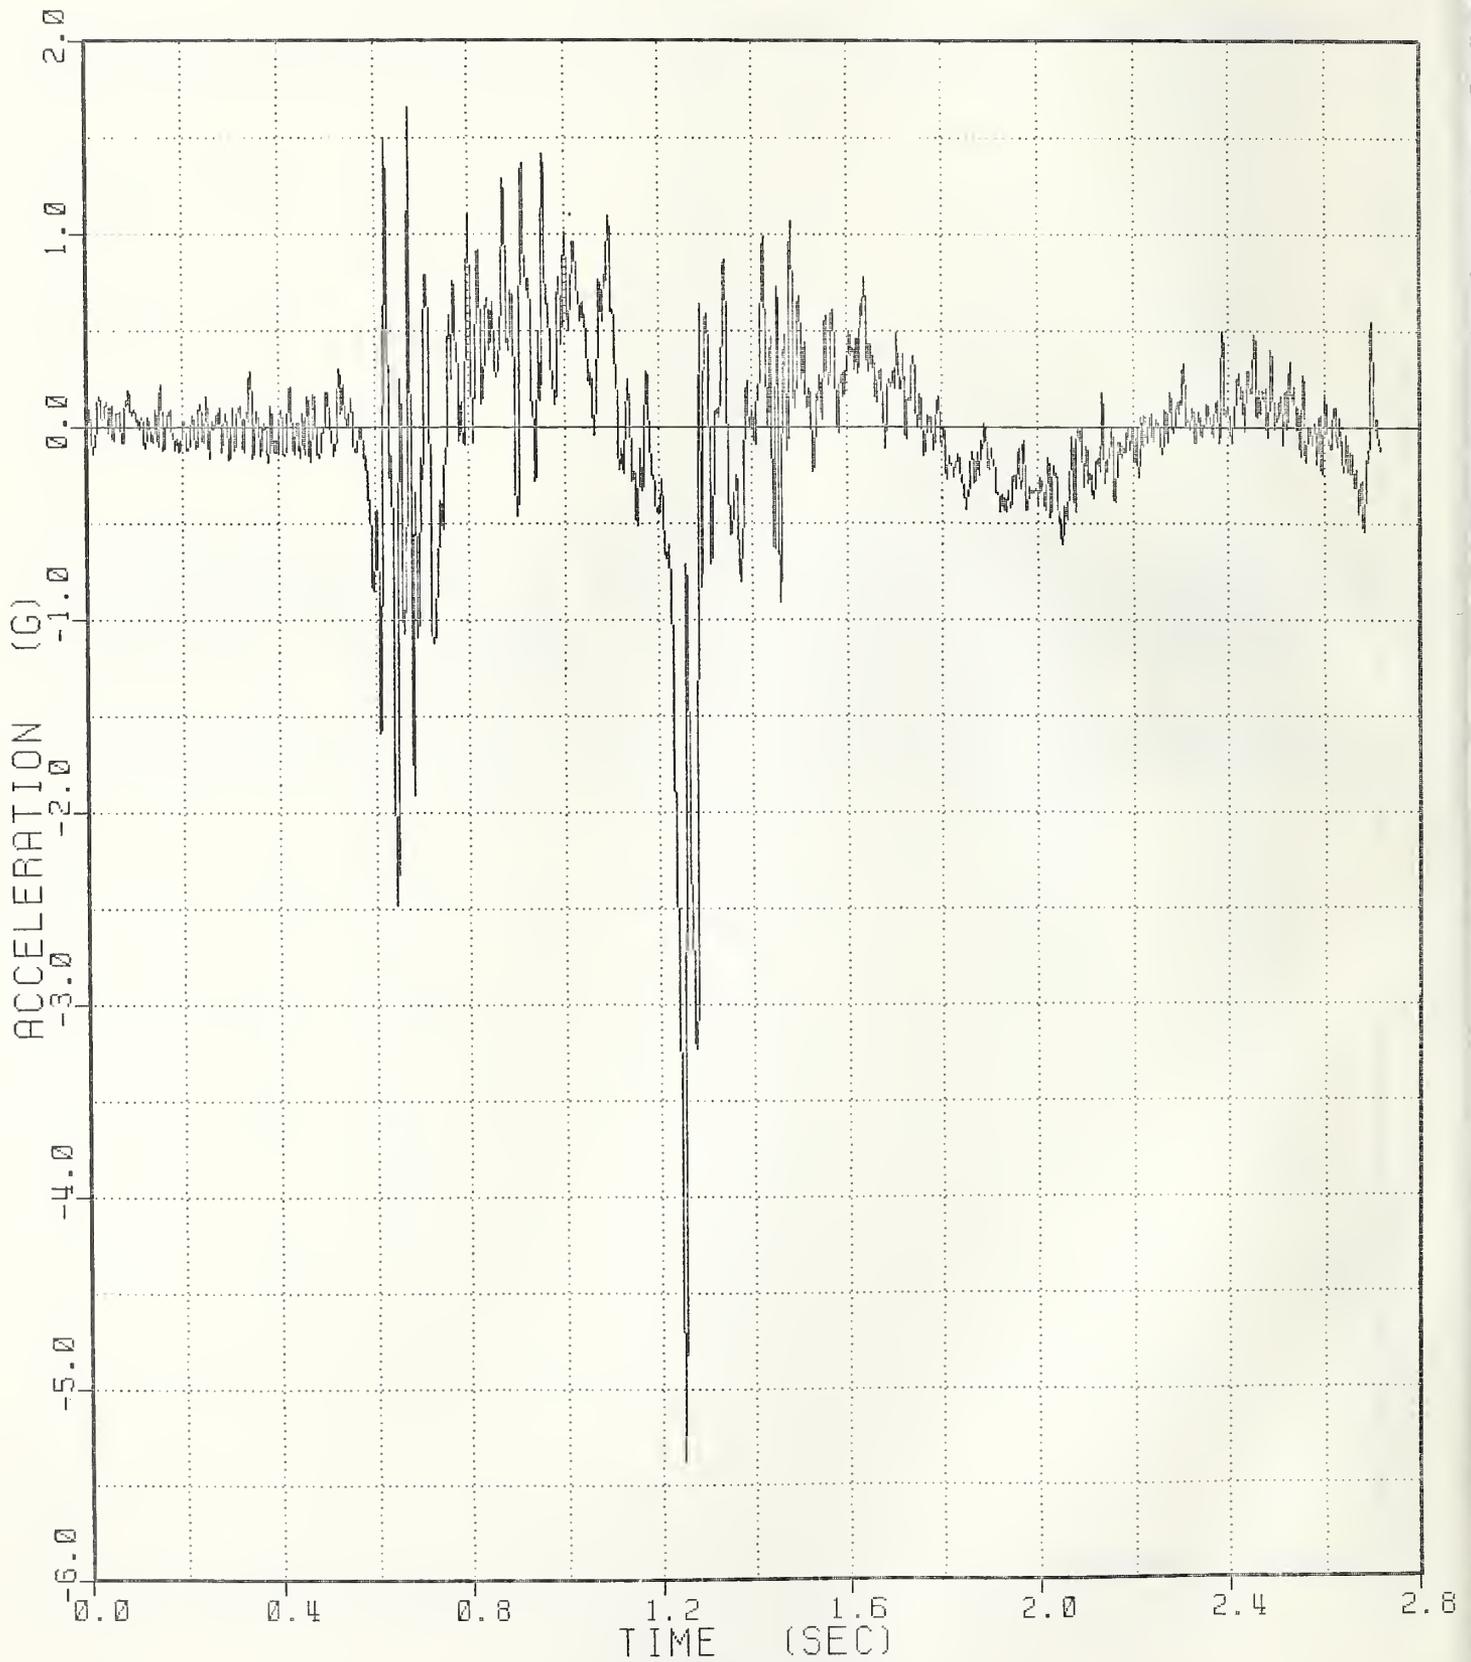
SCAPG2 - Same as above except at the top end of the steering column.

030ZF RD583-2 TST030 84171083915 28-AUG-84 16:06:36
SCAPG2 FILTER = BLPP 100/ 316/ -40 0.0 MPH
MIN, MAX VALUES = -5.38375 1.2480 1.65504 0.6720
